*A Report on the*  
**AIRLIFT**  
*Berlin Mission*

**THE OPERATIONAL AND  
INTERNAL ASPECTS OF  
THE ADVANCE ELEMENT**

PREPARED BY HEADQUARTERS  
COMBINED AIRLIFT TASK FORCE

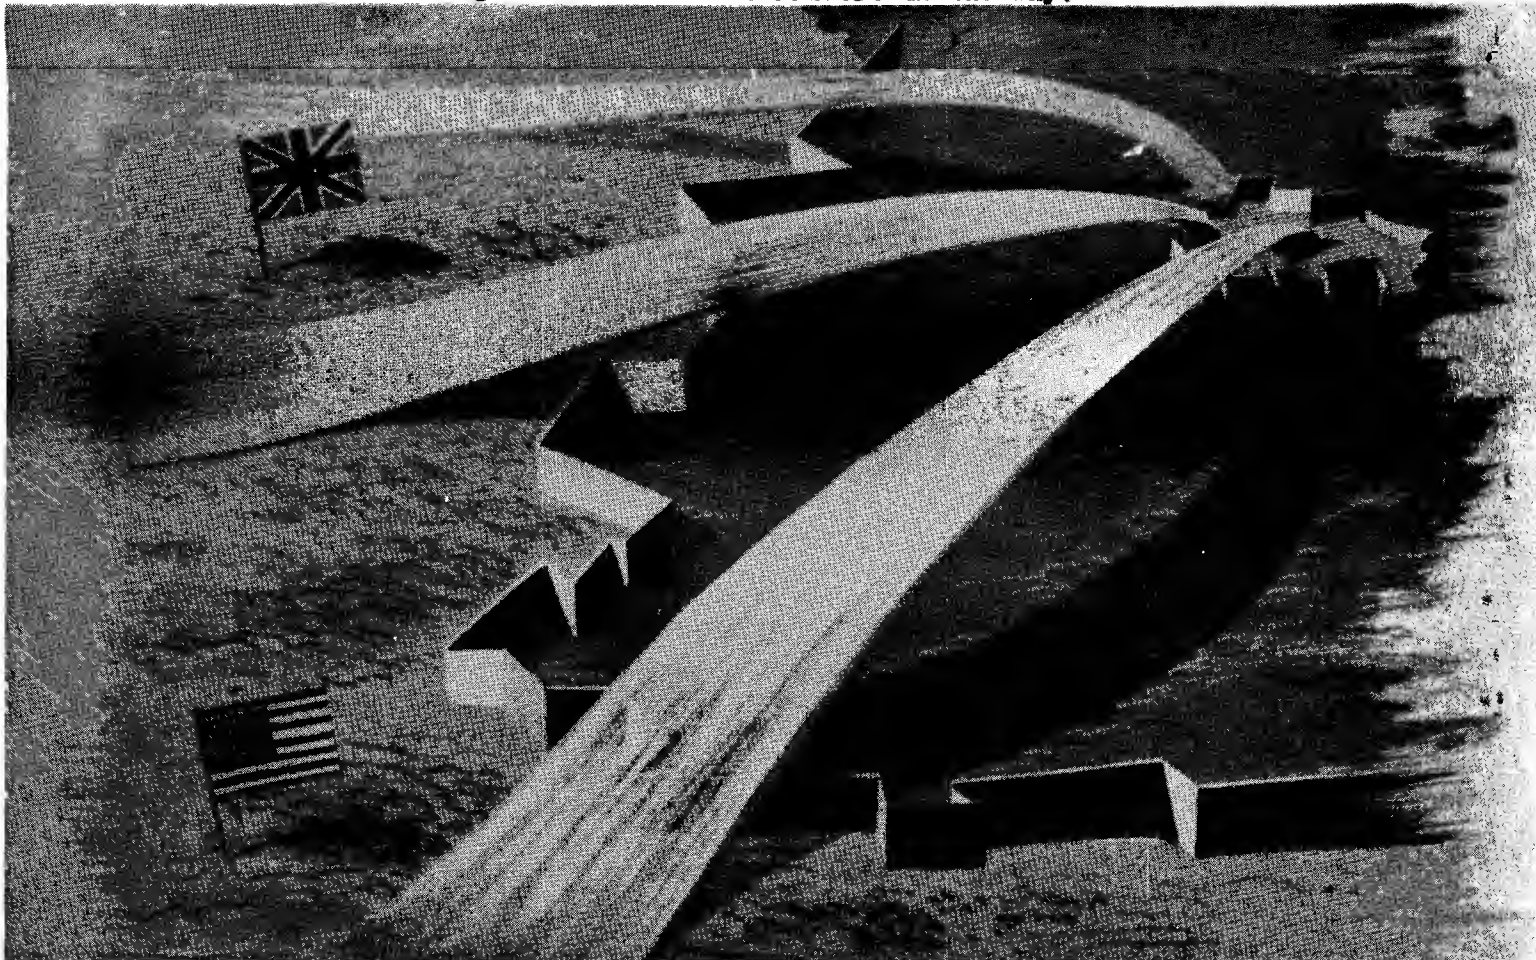
● The "Blockaded Island" — Berlin — accessible only through three limited corridors in the sky.

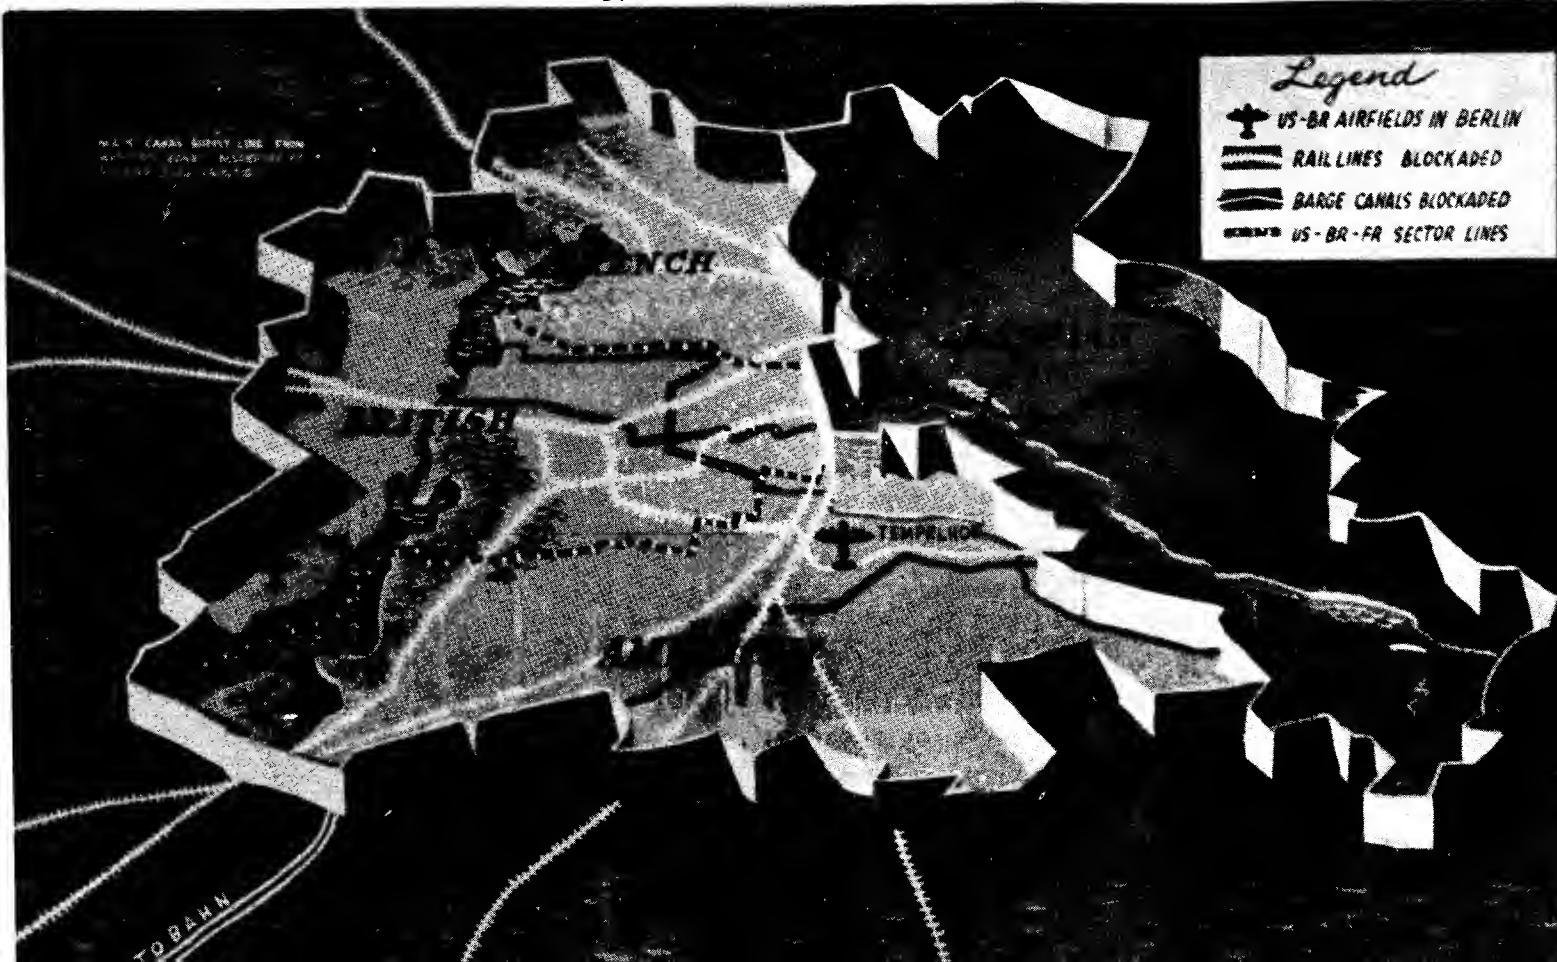
- Rail, barge and highway paths blockaded, thereby stopping the flow of supplies to the Western Sectors of Berlin.

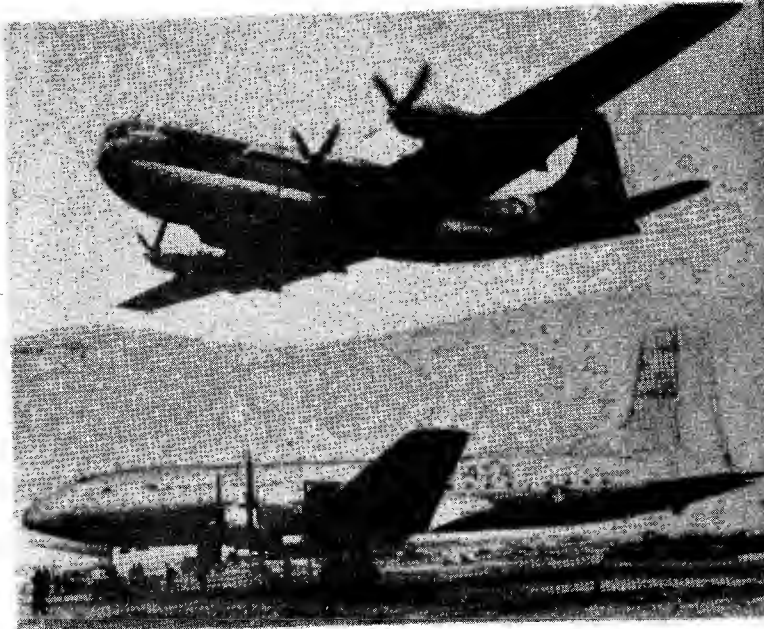
Two of the largest aircraft used. The C-97 (top) and C-74 both were classed as 20-ton transports on the Airlift.

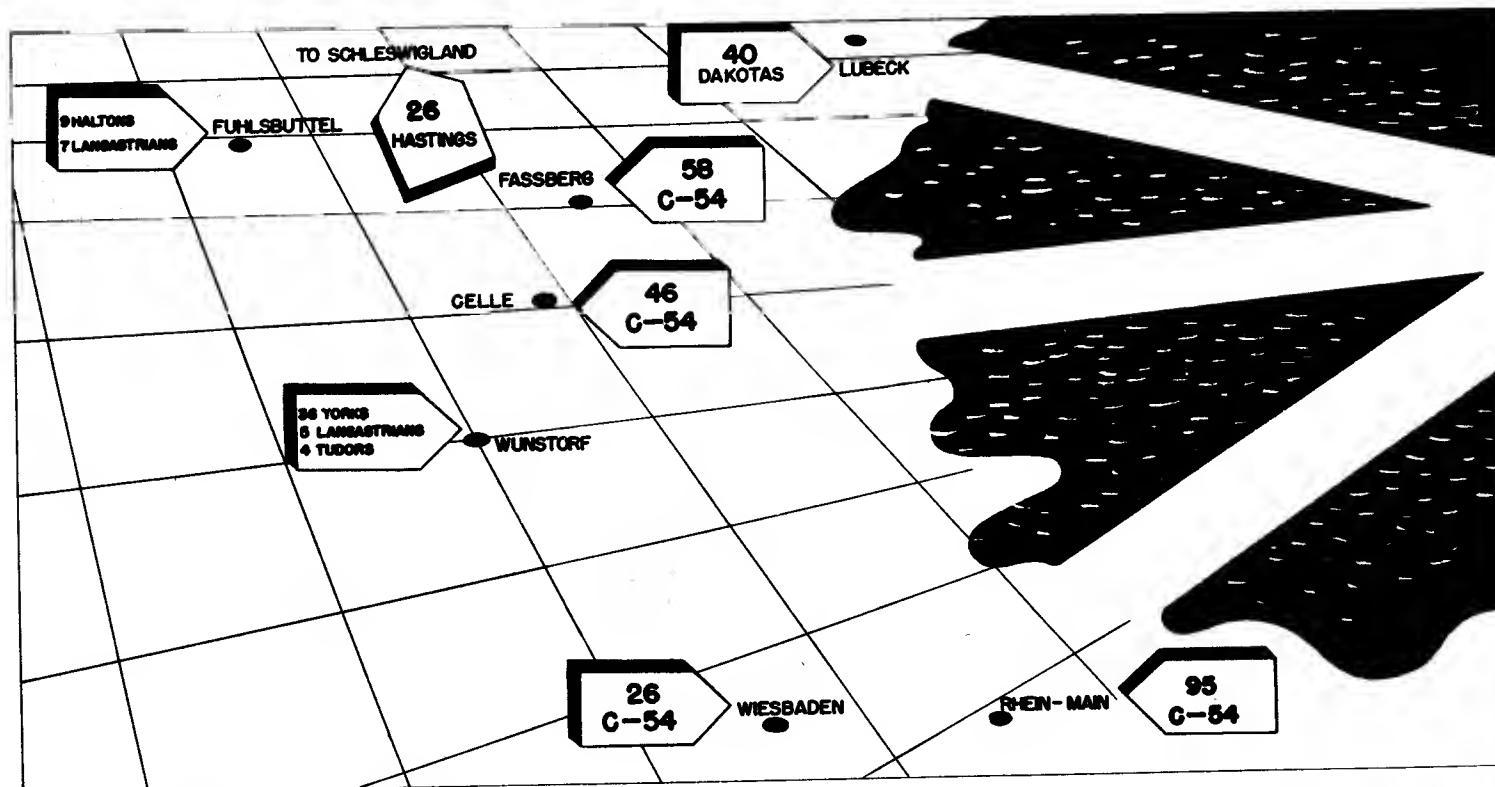
Airlift bases and the number of aircraft stationed at each, prior to the phase-out, are shown in the chart below. A more detailed description of each base is given in Chapter V of this report.

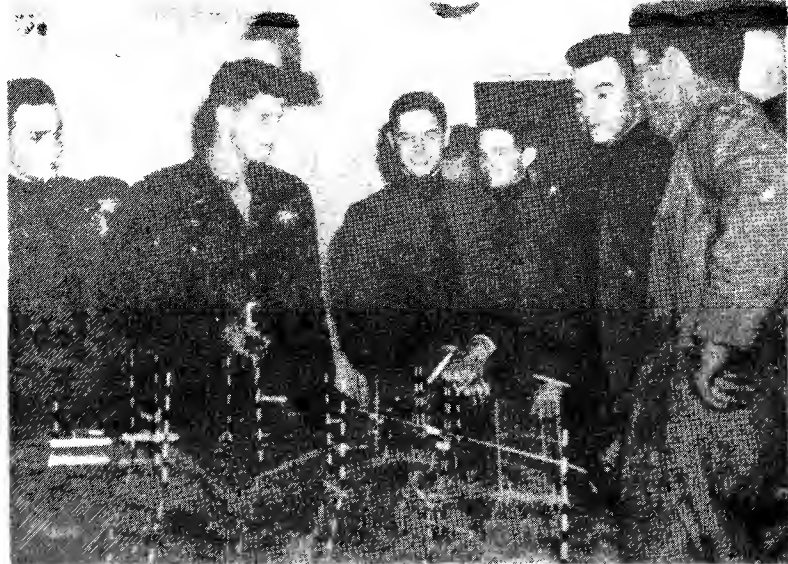
Briefing Table in Use

Immediately after the briefing, pilots were issued complete air navigation and briefing kits, containing up-to-the-minute information of their flight. In addition, the pilot was furnished a flight plan based upon current winds and weather. Alternates were provided with operational minimums and clear weather conditions. Maps, and charts, covering all necessary information for using these alternates, were included in the briefing kit.

One of the most valuable of the briefing materials was a comprehensive Manual of Airlift Routes and Procedures. This manual included a detailed description of the procedures to be followed from each of the Airlift bases to Berlin. In the manual could be found all emergency procedures, missed approach procedures, and in-

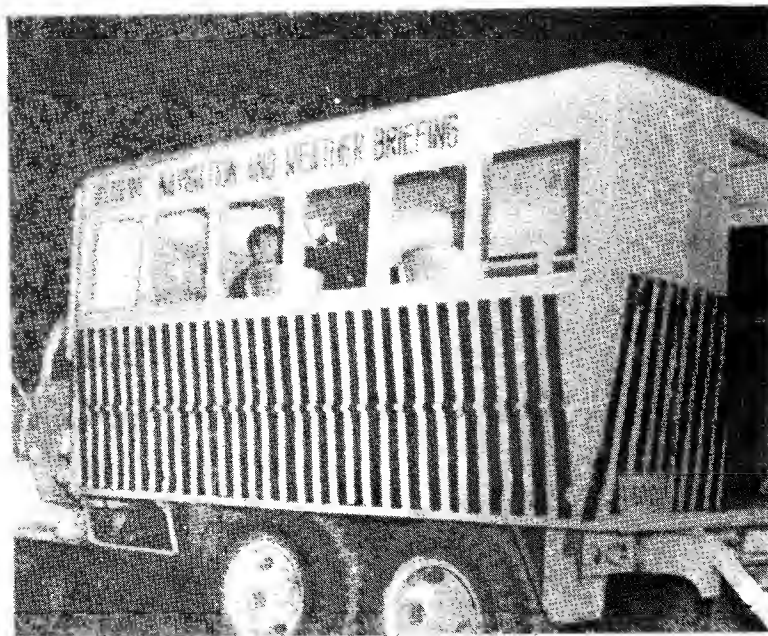
Mobile Briefing Unit in Berlin

As in the entire Airlift operation, every effort was made in briefing to minimize the time aircraft remained on the ground. As an example, at Tempelhof a mobile briefing truck met arriving crews, and a rapid but thorough weather briefing and flight plan for the return trip was given each pilot. This unit also served as a de-briefing agency for any crew having pertinent information to divulge. At the home base, de-briefing by weather and in-

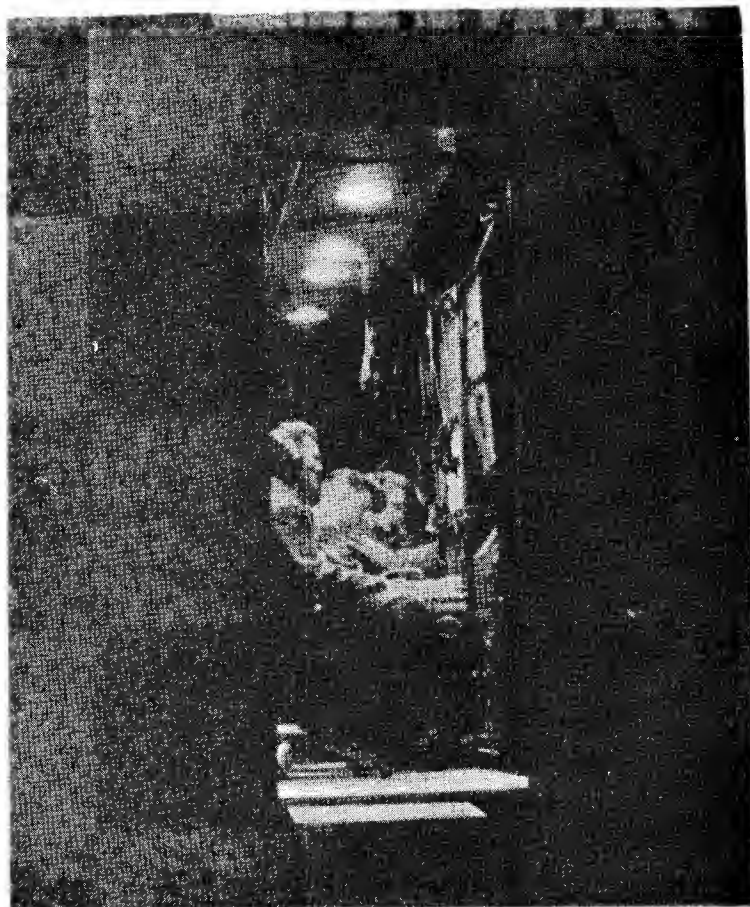
GCA During Night Operation

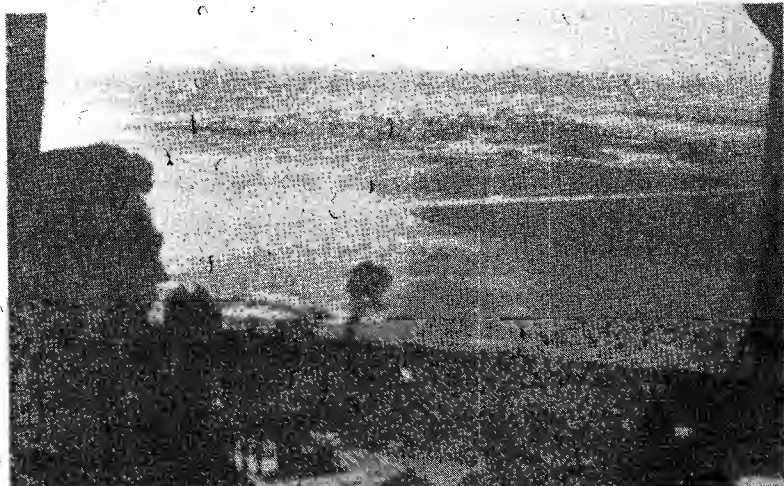
Controlling from Tempelhof Tower

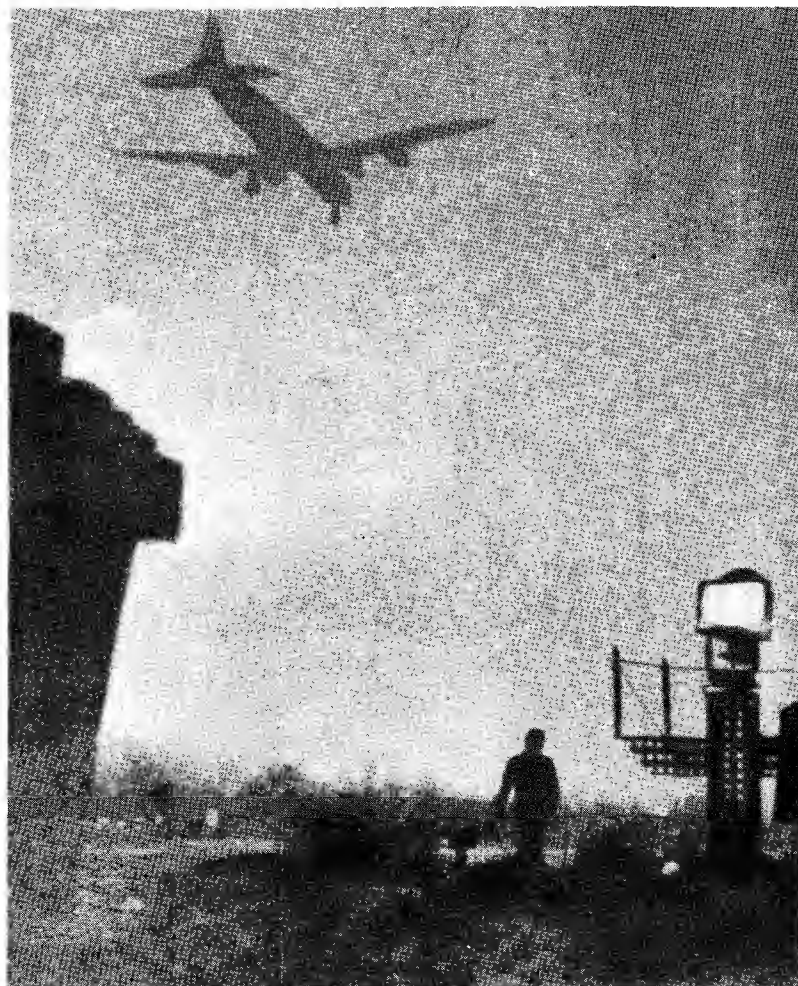
● Approach under Fog Conditions

In this operation an effort was made to improve reporting accuracy, and by means of an observer on the end of the runway, a temporary solution to the runway visibility problem was found. The Airlift's requirements were at least a stimulus to the development of an instrument called a transmissometer, which will give a continuous recording of the very important approach ceiling and visibility. It was recommended that a second set of wind-recording instruments be placed on the ground near the end of the runway to

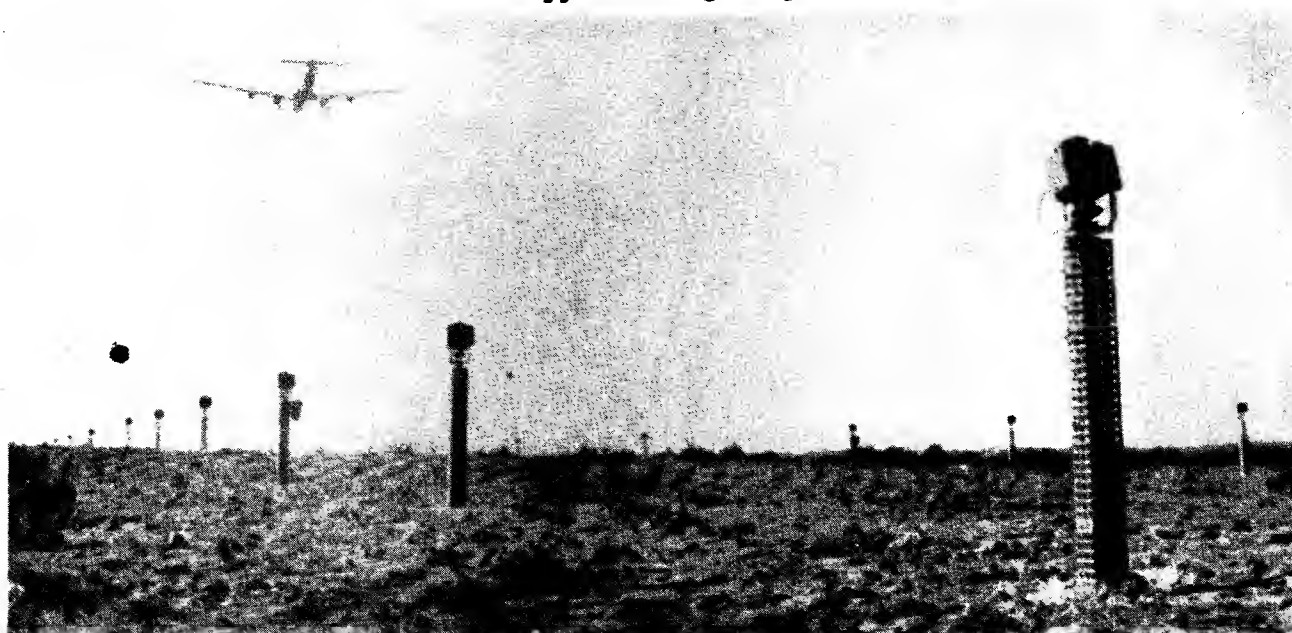
● A Twin-row Approach Lighting Installation

was employed at Gatow, Celle, Wunstorf, and Fuhlsbüttel, and was scheduled for future installation at other RAF stations.

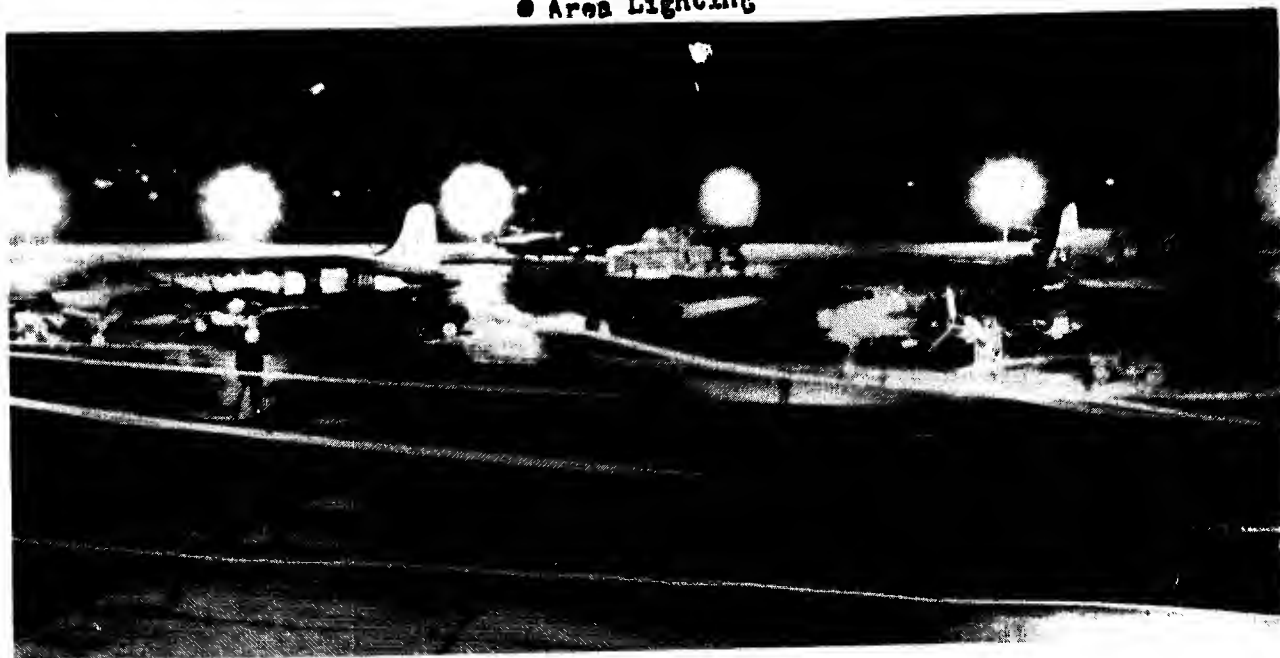
● Area Lighting

"Artificial Moonlight". trials were carried out at Wunstorf and Celle by using three search lights turned to form an apex over the loading area. Results were not satisfactory and the trials were discontinued. The limitations were obvious, inasmuch as the success was influenced by the height of the cloud base in the region. At Celle, two 60-foot towers, each carrying a circular cluster of 12 Holophane wide-beam 500-watt lamps, were erected in the marshaling area. This method proved the most satisfactory, but experiments still can be made to increase the efficiency of this form of lighting. An obvious advantage is, of course, that a maximum amount of light is obtained with a minimum obstruction risk to aircraft. It is considered that a system is required whereby the source of light is concealed, but at the same time provides sufficient radiation to illuminate the loading area without shadow.

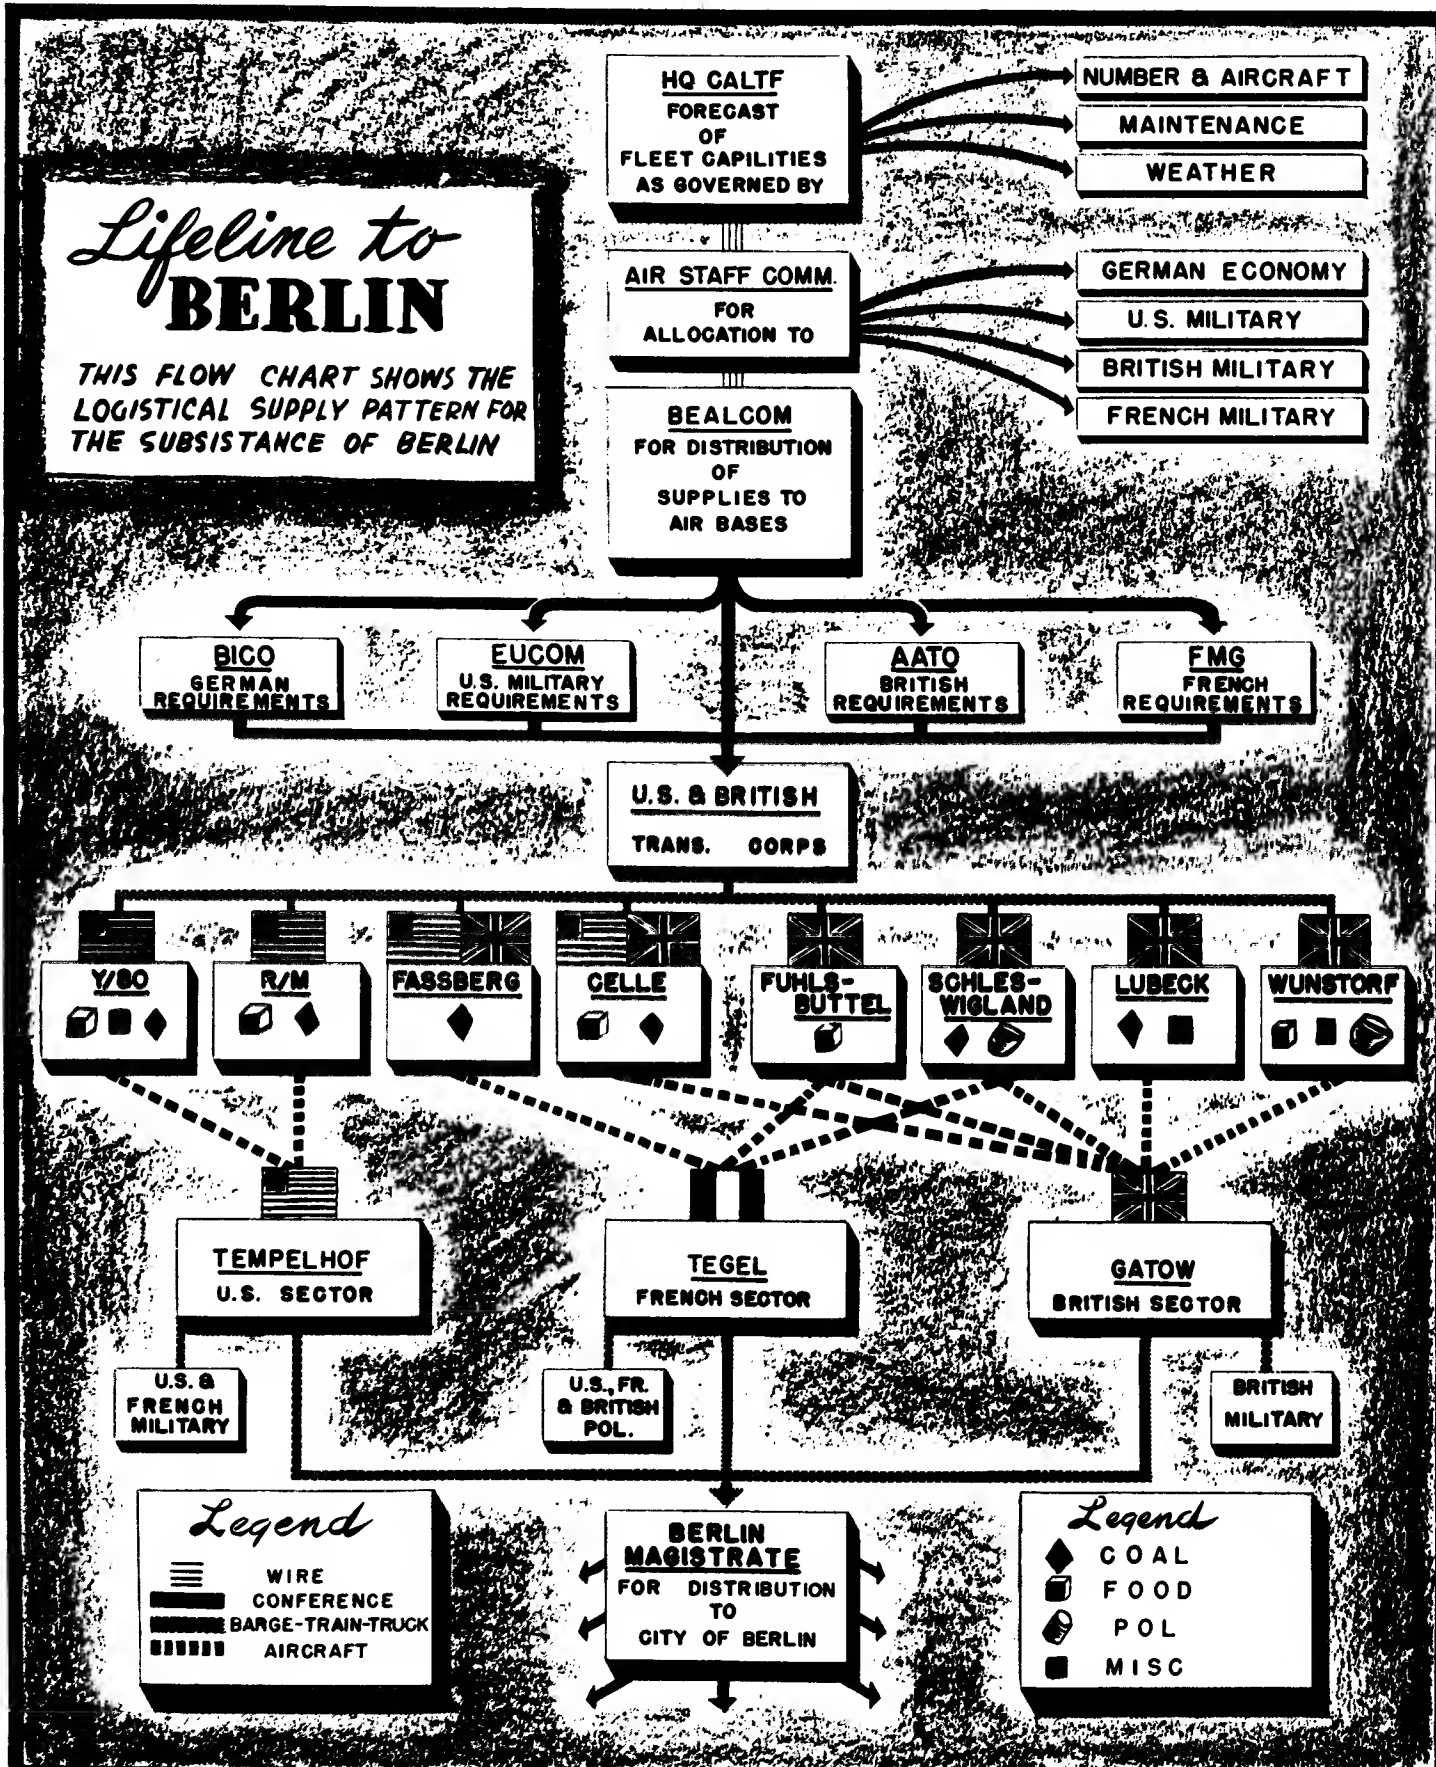
The planning necessary to insure delivery of proper supplies to pre-designated airfields involved several agencies. This pattern is reflected in the chart below, depicting the functions of each agency and the resultant flow of cargo into Berlin.

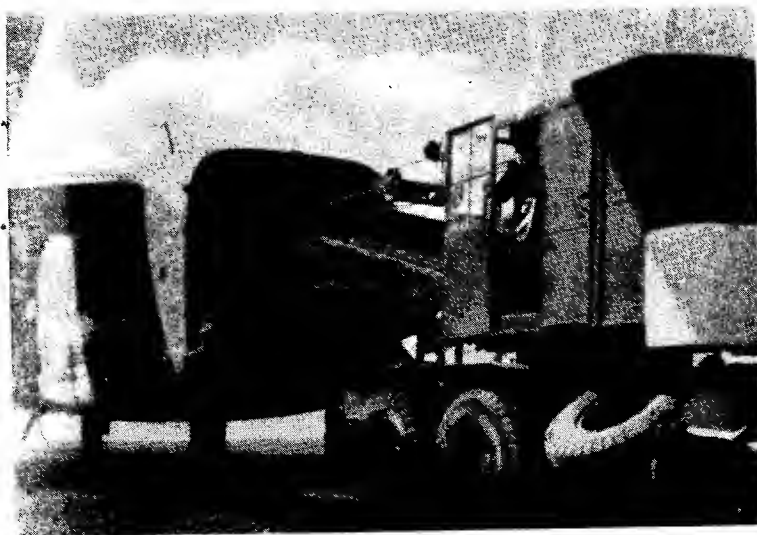
• Conveyor belts used in 20-ton transports.

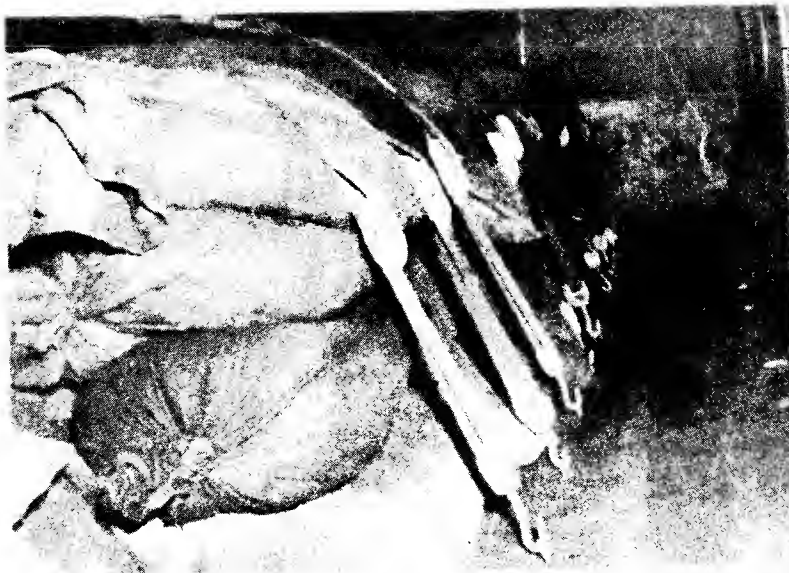
Web strap tie-down equipment was used.

Along with the web strap, a steel cable tie-down was introduced for securing high-density cargo, such as construction machinery. Aircraft used for transporting machinery were equipped

with this cable tie-down, and very satisfactory results obtained. Some difficulty was noted in the design and the lack of elasticity made it undesirable for cargo which settled or packed down during the vibration encountered in flight.

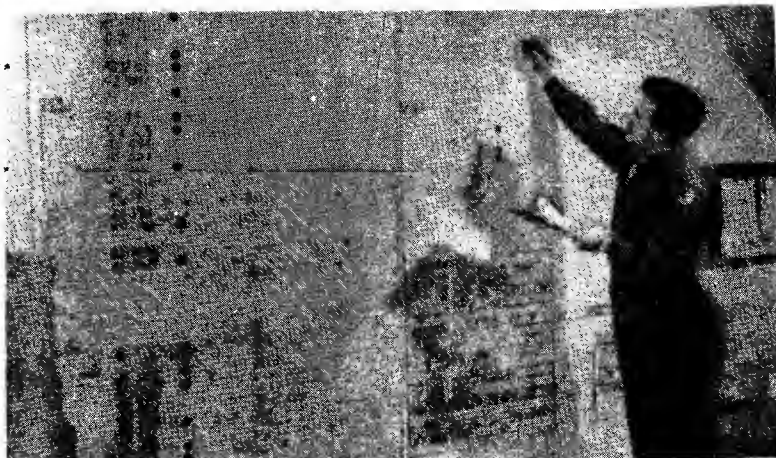
#### CALTF Maintenance Control Board.

A color scheme, universal for all command levels, was adopted to indicate status of aircraft undergoing maintenance. At this time, CALTF Form No. 10 was devised, which provided a complete historical record of each USAF aircraft, and furnished necessary detailed information for comparative studies between groups and squadrons.

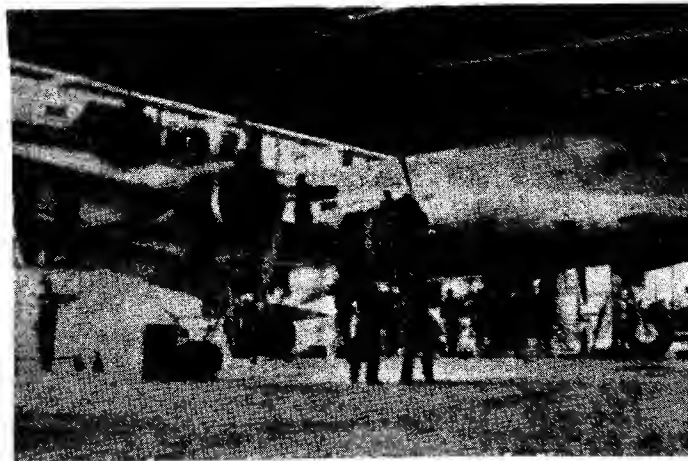
#### 200-hour inspections

During this period, the condition of the entire fleet again deteriorated considerably. It was not until March that Burtonwood was able to accomplish six inspections daily, and then the output increased to eight during April and May. By 15 April, 10 months after the start of the operation, Burtonwood could perform the required number of inspections, eliminating the need of 200-hour inspections at the operating

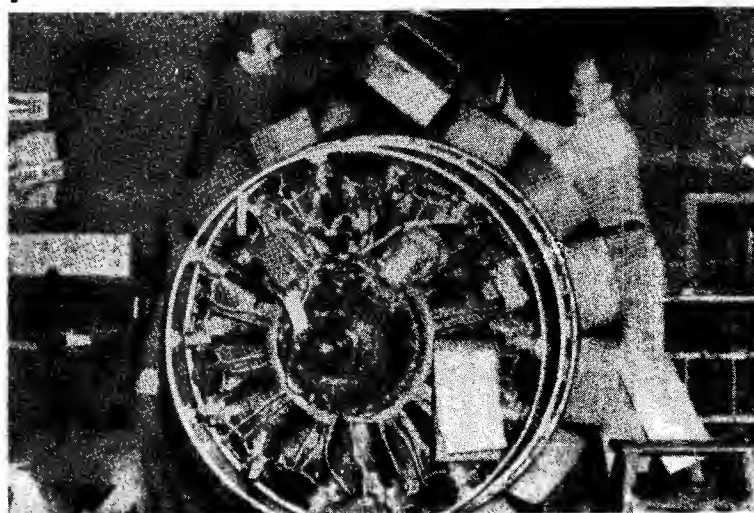
● R-2000 engine buildup.

In the early phases of the Airlift there was a critical shortage of both R 2000-9 and R 2000-11 engines. The situation was so acute for a time that it was necessary to install both R 2000-9 and R 2000-11 engines on the same aircraft. By March 1949, the availability of replacement engines permitted engine conditioning.

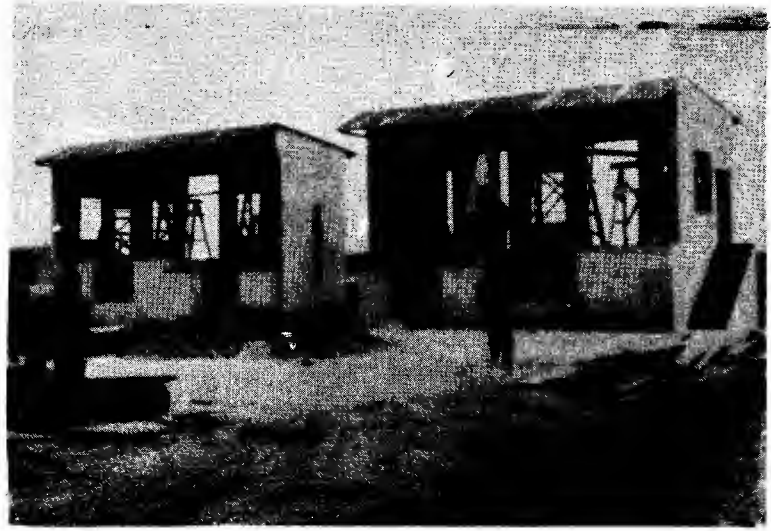
● Permanent C-54 maintenance dock.

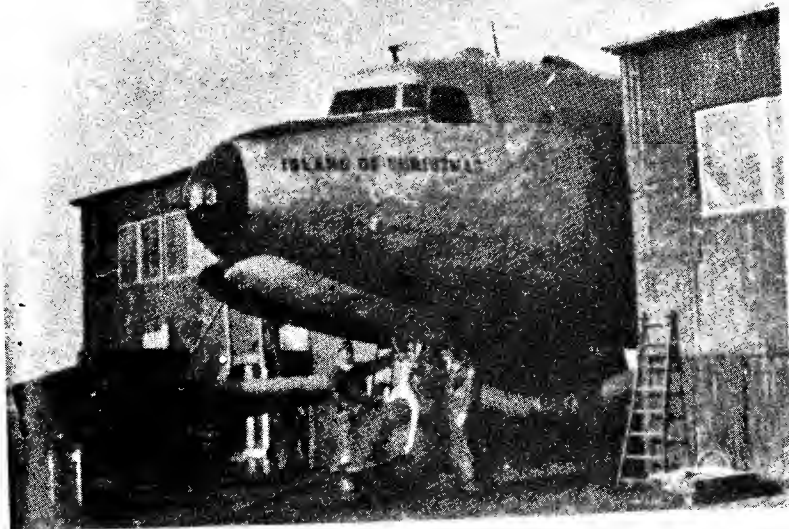
● Temporary maintenance dock.

During the operations, four work-dock fires completely or partially destroyed the aircraft undergoing maintenance. In each case the docks were constructed of wood, on dirt foundations, with improvised lighting, since vapor-proof cords and bulbs were unobtainable. Generally they were in unsafe condition. Plans called for replacement with masonry docks on concrete floors when the phase-out began.

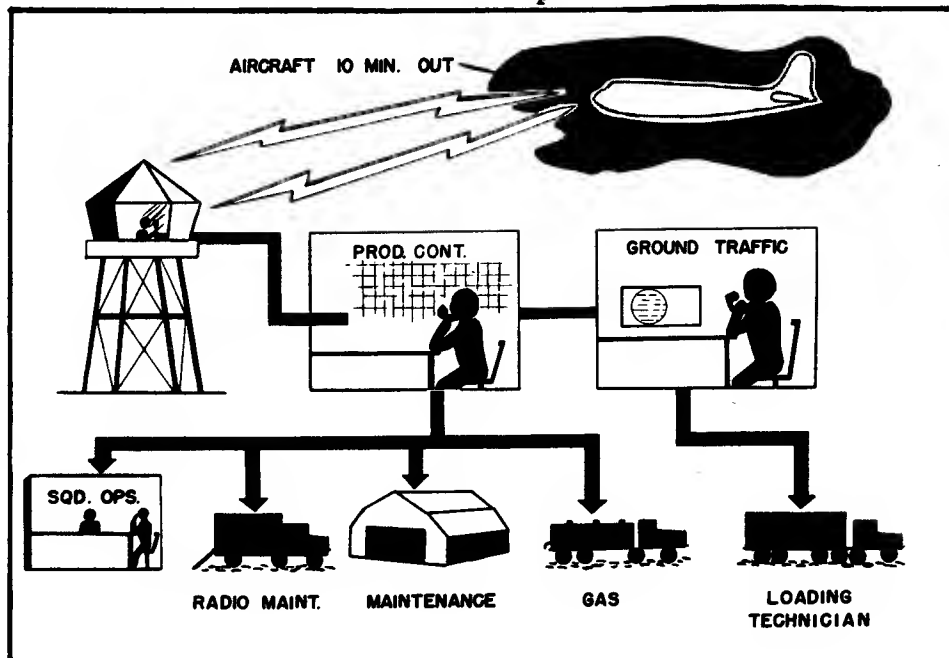
The diagram at the right reflects the "Call-in" procedure adopted by Production Control. This system enabled advance preparation by the sections involved in ground-handling, servicing and maintenance.

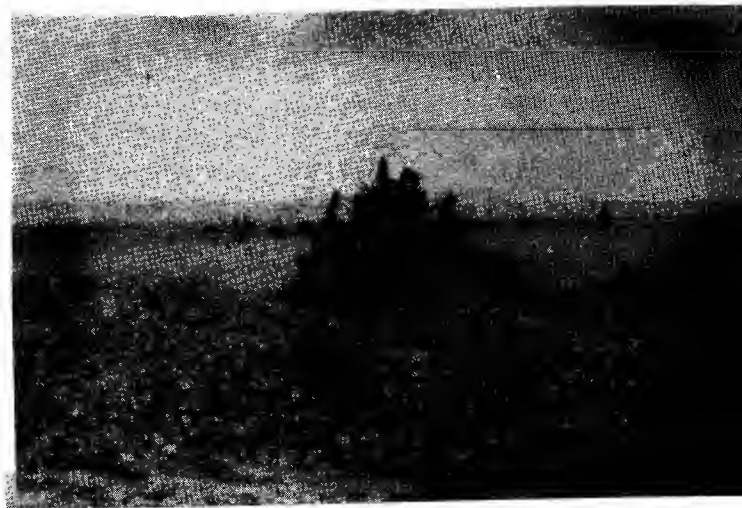
### ● Runway construction in Berlin

Tempelhof, main terminus of C-54 operations, originally had only one runway, but two additional parallel runways were constructed. Both of the new runways were built of compacted brick rubble 18 inches thick, topped by six inches of crushed rock and asphalt surfacing. The original runway was 4,987 by 120 feet and the others 5,750 by 140 feet and 6,150 by 140 feet. Gatow had a concrete runway 6,000 by 150 feet and this was augmented by a second runway topped with pierced steel planking. Another concrete runway was under construction when the blockade was lifted.

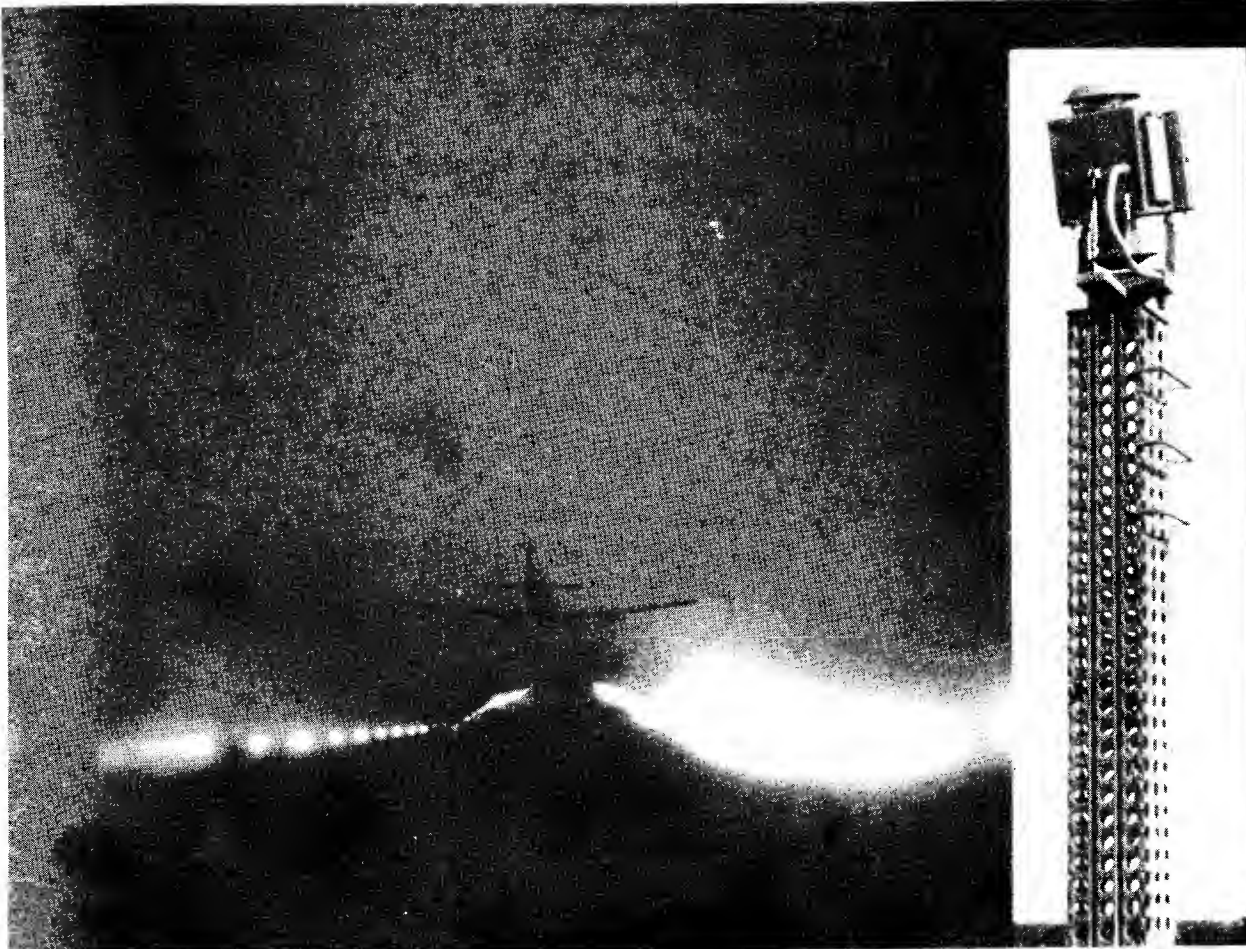
◆ High Intensity Lighting.  
Insert shows detail of construction.

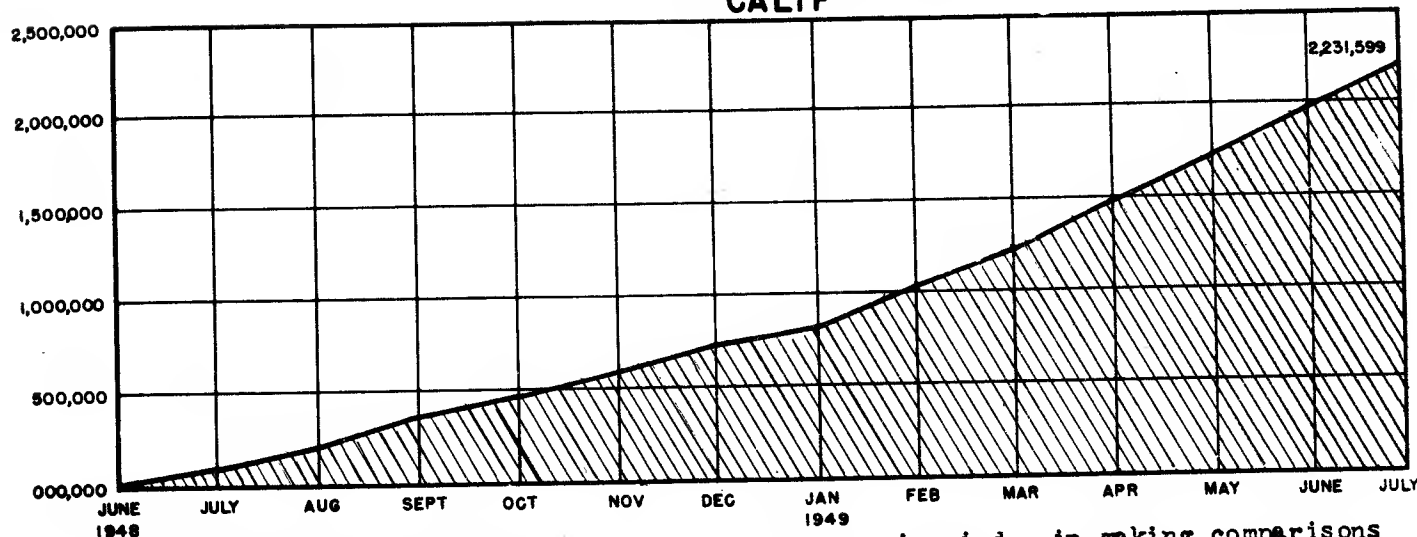
### TOTAL TONNAGE AIRLIFTED CALTF

USAF: Food, 296,303.1 tons. Coal 1,353,813.4. Other, 65,464.1. Total, 1,715,585.6.

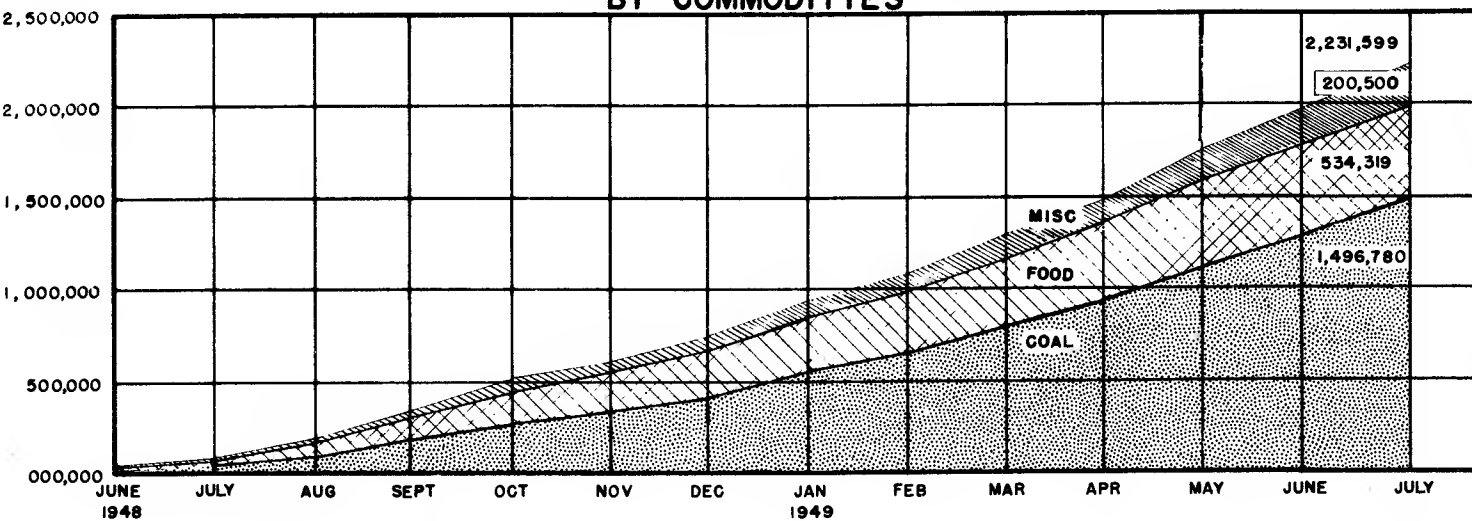
## TOTAL TONNAGE AIRLIFTED BY COMMODITIES

It is significant that 67 per cent of the total tonnage transported was coal. The complex economic life of modern times is well illustrated by this basic need.

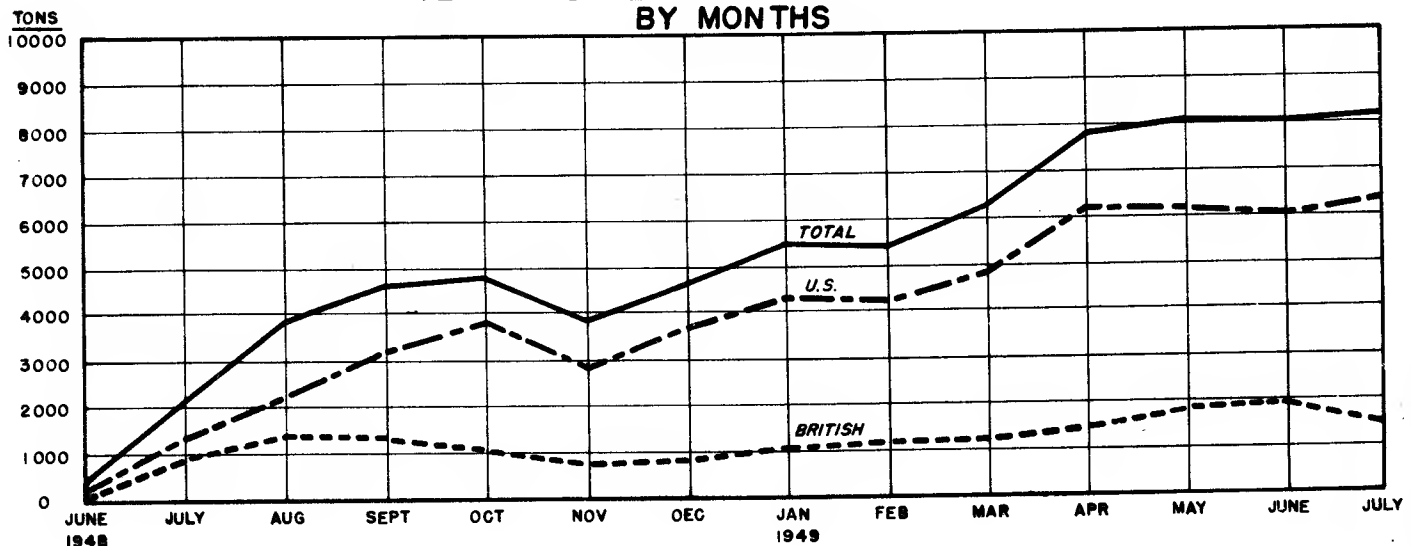
## AVERAGE DAILY TONNAGE AIRLIFTED BY MONTHS

At the beginning of the Airlift 4,500 tons per day was established as the minimum daily requirement and was set forth as the daily mission. This target was met in September and October, but efforts fell short by approximately 800 tons daily in November. The target was reached again in December and the total effort far exceeded the daily tonnage target for the remaining months of the Airlift. The six-month period from October until April re-

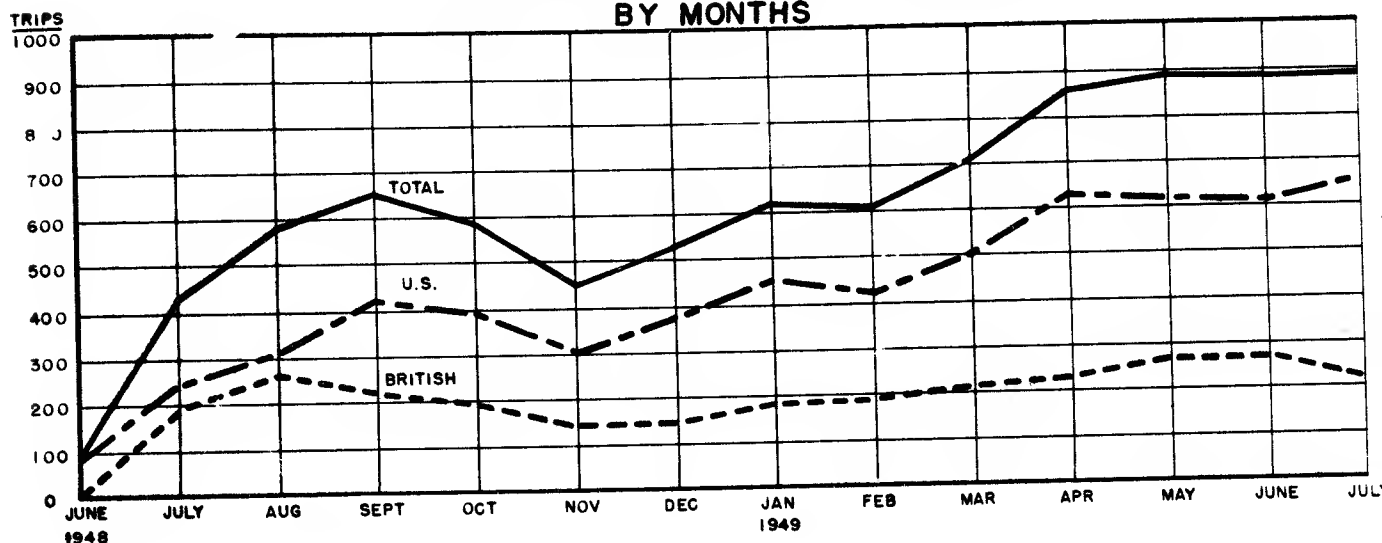
**AVERAGE DAILY TRIPS TO BERLIN  
BY MONTHS**

per day, or more than one landing or take-off during every 60 seconds in the 24-hour day. Each airport, therefore, was approaching maximum utilization. For example, Tempelhof was averaging nearly 325 landings per day or 67 per cent of the maximum possible on a three-minute interval between flights.

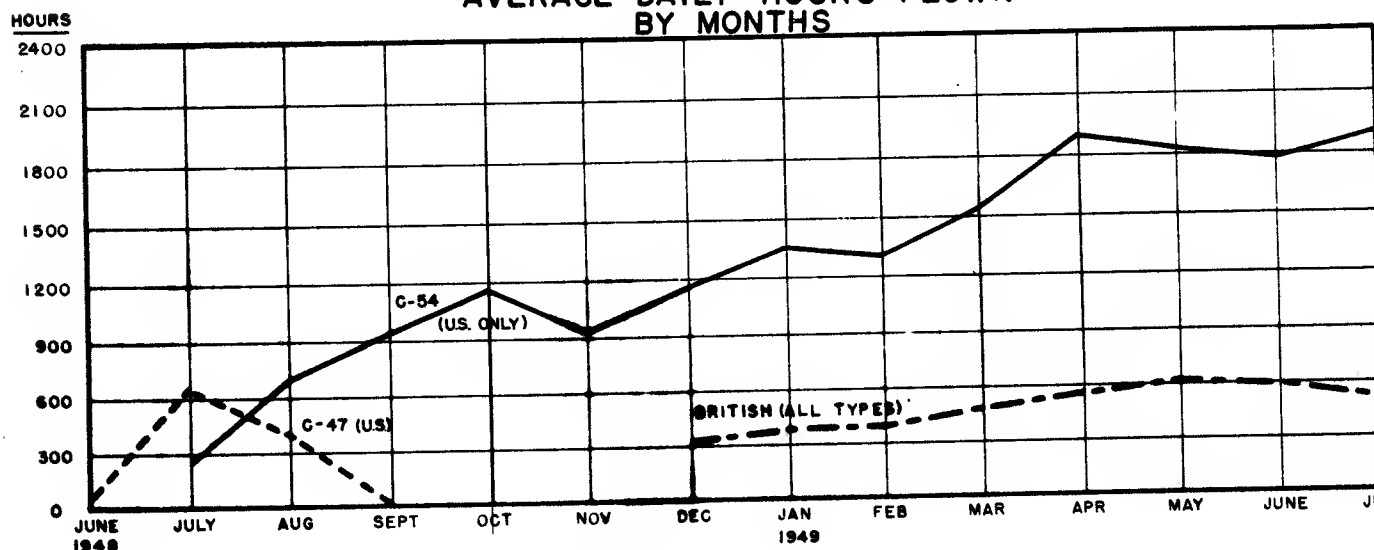
**AVERAGE DAILY HOURS FLOWN  
BY MONTHS**

752 flying hours during the eight-month period from 1 December 1948 through 31 July 1949. During the sustained operations, the USAF C-54 units averaged better than 1,800 total flying hours per day, while RAF units averaged 600 total hours per day.
